NONDESTRUCTIVE EVALUATION OF METAL FATIGUE

FINAL SCIENTIFIC REPORT

SwRI Project No. 15-4163

Air Force Office of Scientific Research

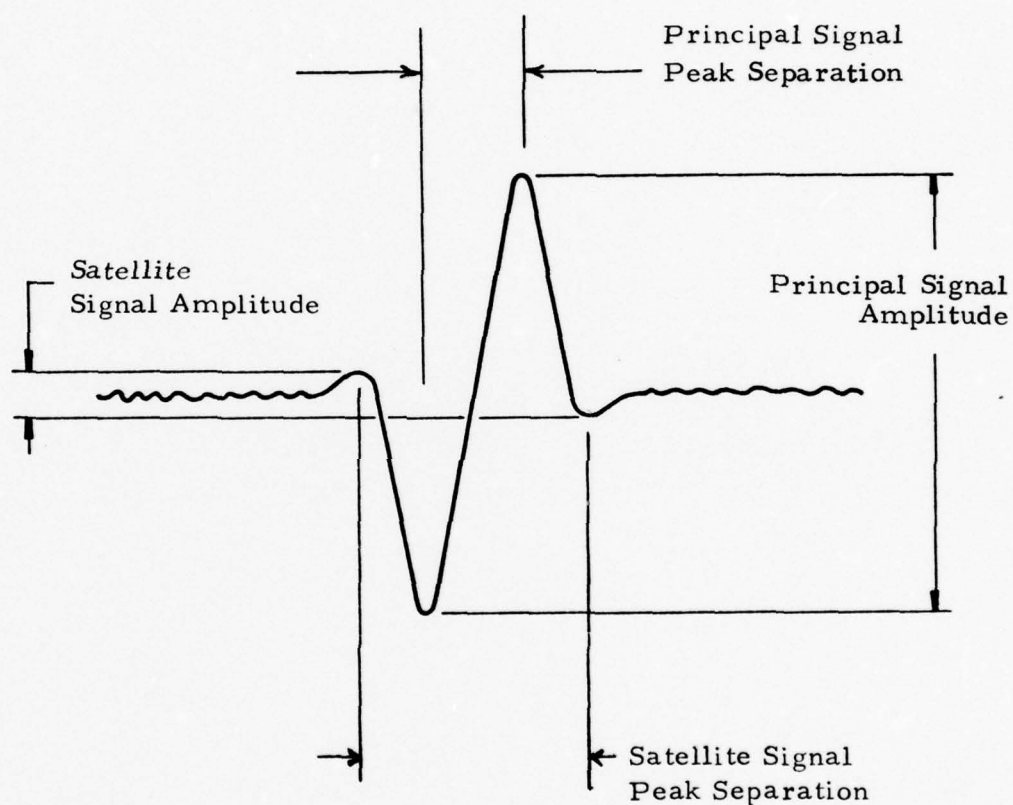
FIGURE 2. CHARACTERISTIC MAGNETIC SIGNATURE ASSOCIATED WITH A SURFACE CRACK

Magnetic perturbation signals were obtained with a small Hall effect probe (0.001-in. x 0.004-in.). The probe was mechanically moved on a precise path along the specimen axis (perpendicular to the crack interface) by means of a scanning mechanism. The width of the scan track interrogated by the probe is not precisely known, but it is probably no more than 0.002-in. In general, prior to stress cycling, the specimens were surveyed with the magnetic perturbation instrumentation. The specimens were then stress cycled in tension to initiate fatigue cracks. The fatigue machine was stopped at various stages of crack growth and for each crack length magnetic perturbation measurements were made at different values of applied static stress up to the maximum cyclic stress. Data were obtained with the specimen magnetized nearly to saturation using a magnetizing current of 6.0 amp (hereafter referred to as the "high field" or HF condition) and also at a lower magnetizing current of 0.8 ampere ("low field" or LF condition). For each crack length and applied stress, magnetic perturbation signatures were obtained from a number of adjacent tracks perpendicular to the crack interface. As reported previously⁽²⁾, the signature usually consists of two components as shown in Figure 2. The signal parameters extracted for analysis were:

Measurements were made of the separation between the peaks of the magnetic perturbation signal (refer to Figure 2) in order to explore the possible relationship between this parameter and the crack geometry. In general, the peak separation of both the principal and satellite components is less at the interior regions of the crack than at the tips, as shown in Figure 9 for Specimen S5. These results are observed consistently for all crack lengths and applied loads investigated. Although no detailed explanation has been developed at this time, these results suggest that peak separation may be related to stressed zones around fatigue cracks. This hypothesis is supported by the observation that for low magnetic fields the variation in signal peak separation from interior regions of the crack to the tip is greater than for the high field case (see Figure 9).

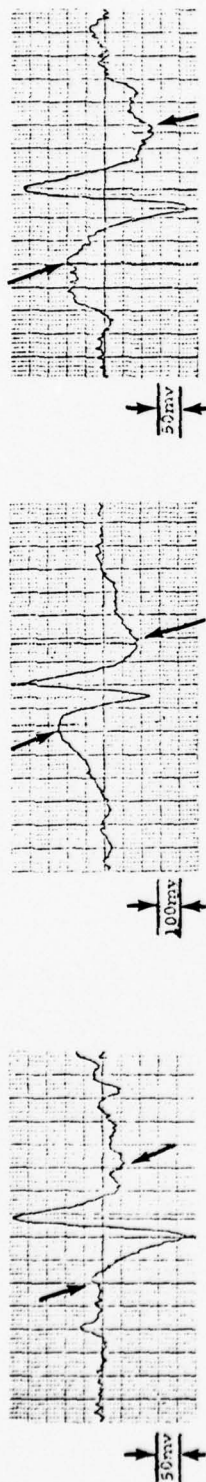
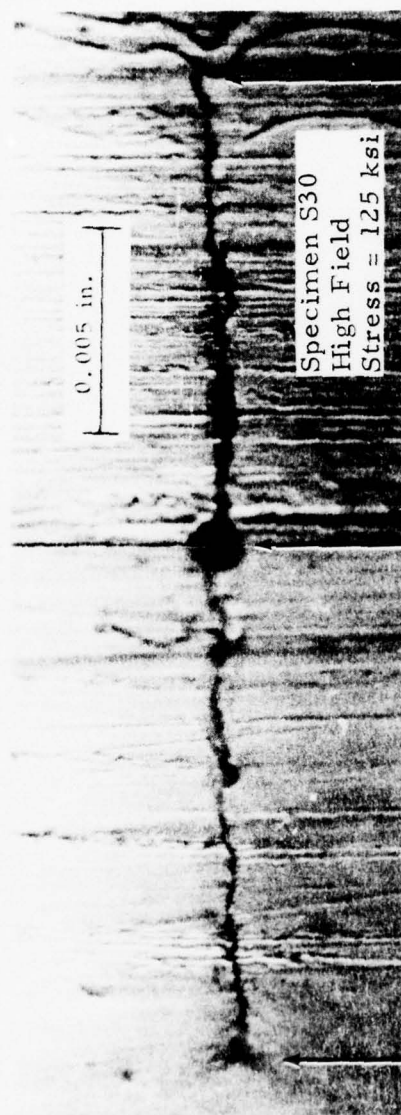
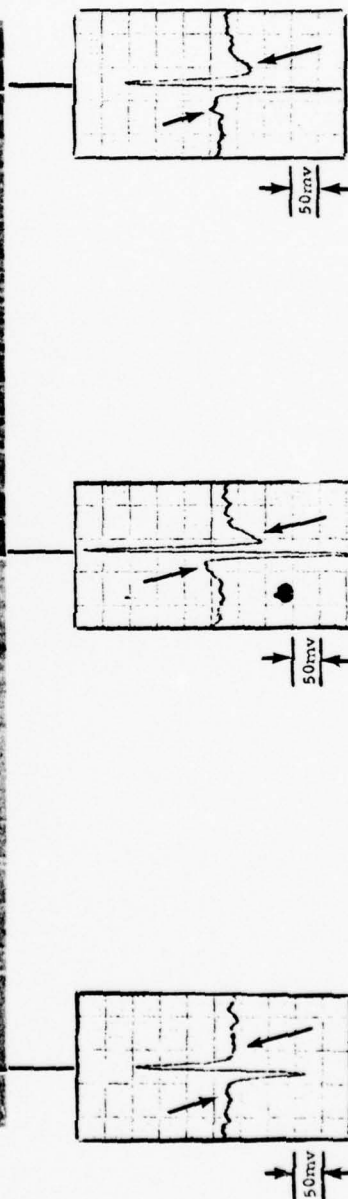
HY-180 (Specimen H-1, High Field, Stress = 170 ksi)

FIGURE 3. CHARACTERISTIC MAGNETIC PERTURBATION SIGNATURES
AISI 4340

Figure 3 presents characteristic magnetic perturbation signatures obtained at several locations along a 0.025-in. -long fatigue crack in AISI 4340 steel (Specimen S30) and also along a 0.026-in. -long fatigue crack in HY180 steel (Specimen H1). The crack shown in the illustration was in the AISI 4340 specimen and the signatures shown beneath the crack were obtained from this specimen. The signatures above the crack photograph were obtained from the HY 180 specimen. Examination of these and similar results on cracks of other lengths shows that there are significant differences in magnetic perturbation signature characteristics obtained from

similar length cracks in HY 180 and AISI 4340. For example, as can be seen, the satellite signatures are much more prominent in HY 180 than in AISI 4340 steel. Previous results obtained from fatigue cracks and artificially produced geometric discontinuities, such as electric-discharge machined slots, in AISI 4340 steel, have indicated that the satellite signatures may be associated with elastic and plastic strains⁽⁴⁾. Since the magneto-elastic response of HY 180 may be considerably different from AISI 4340, the prominent satellite signatures in HY 180 could be an aid to fatigue crack detection.

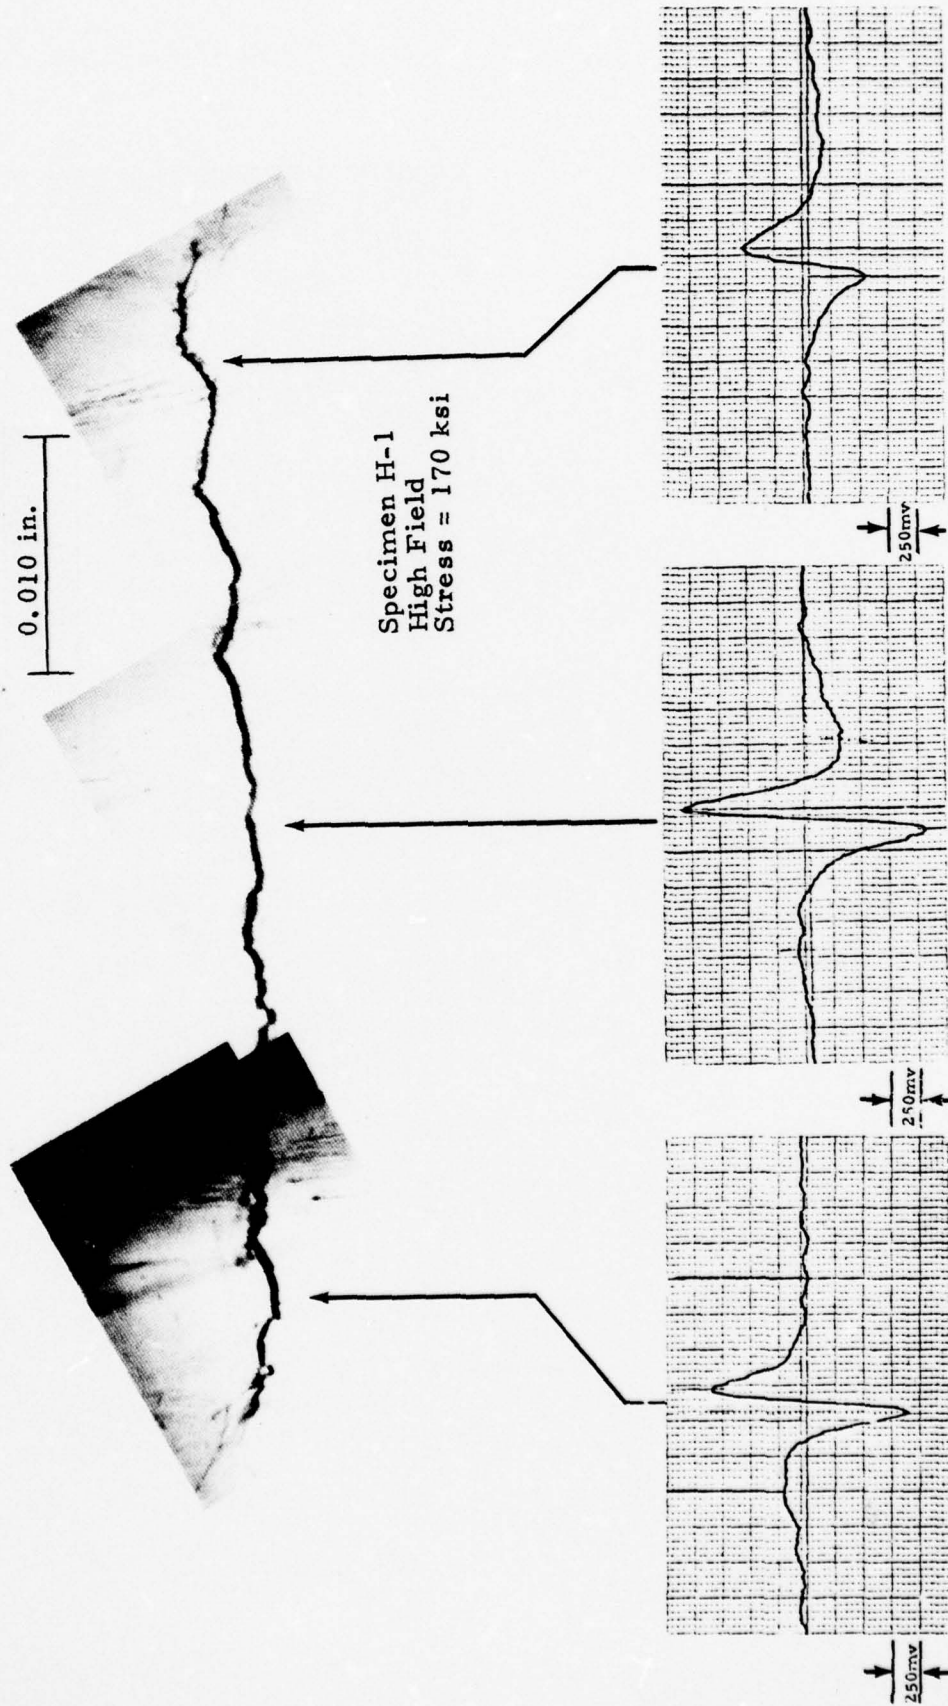
FIGURE 4. FATIGUE CRACK (0.050-in.) IN HY 180 STEEL SPECIMEN WITH ASSOCIATED MAGNETIC PERTURBATION SIGNATURES

Extension of the crack in Specimen H1 resulted in a large increase in amplitude of the principal component but a very small increase in the satellite amplitude. This is illustrated in Figure 4 which shows selected signatures and a photograph obtained after the crack in Specimen H1 was propagated to a length of 0.050-in. For the signature at the center of the crack, the satellite amplitude has increased only slightly (300mV) compared with the satellite (240mV) when the crack was only 0.026-in. long (see Figure 3). By contrast, the principal component has increased dramatically; 2075mV (Figure 4) compared to 640mV (Figure 3).

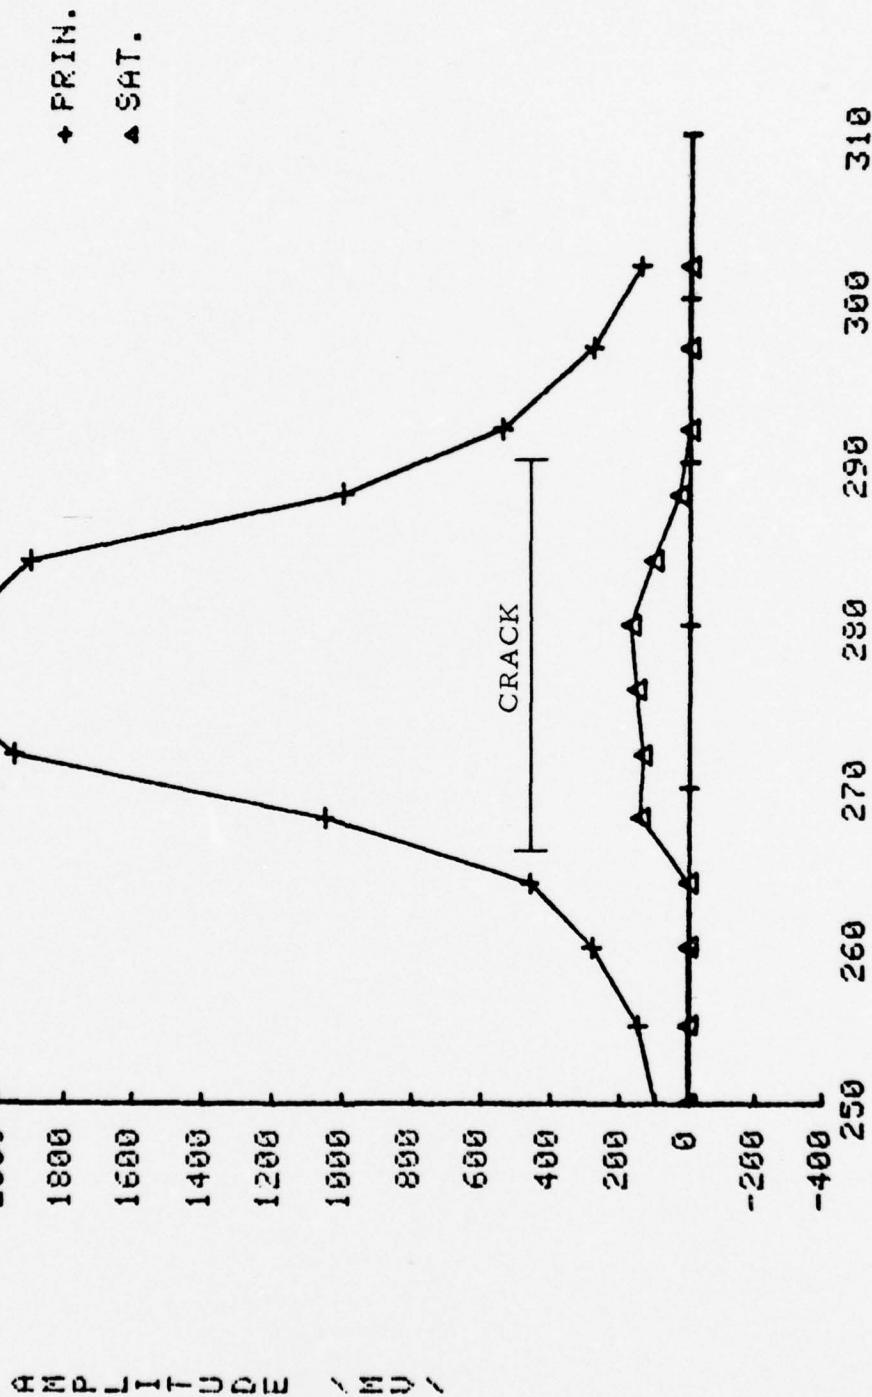
7/9/76 SPECIMEN: S-5 MATERIAL: 4340 STEEL
 CRACK LENGTH: 0.052" NO. CYCLES: 9900 COMMENTS: CRACK "B"
 LOAD: FL FL=180KSI FIELD: HF

FIGURE 5. MAGNETIC PERTURBATION SIGNAL AMPLITUDE VERSUS
 LOCATION ALONG A FATIGUE CRACK.

Representative results for the variation of the magnetic perturbation signal amplitude along the crack interface are shown in Figure 5. These results are for a 0.052-in. -long fatigue crack in AISI 4340 steel (Specimen S5) with an applied static stress of 180 ksi. In general, the satellite component is observed for only a short distance beyond the crack tip, whereas, the principal component is observable well beyond the crack tips. Previous investigations have explored the relationship between

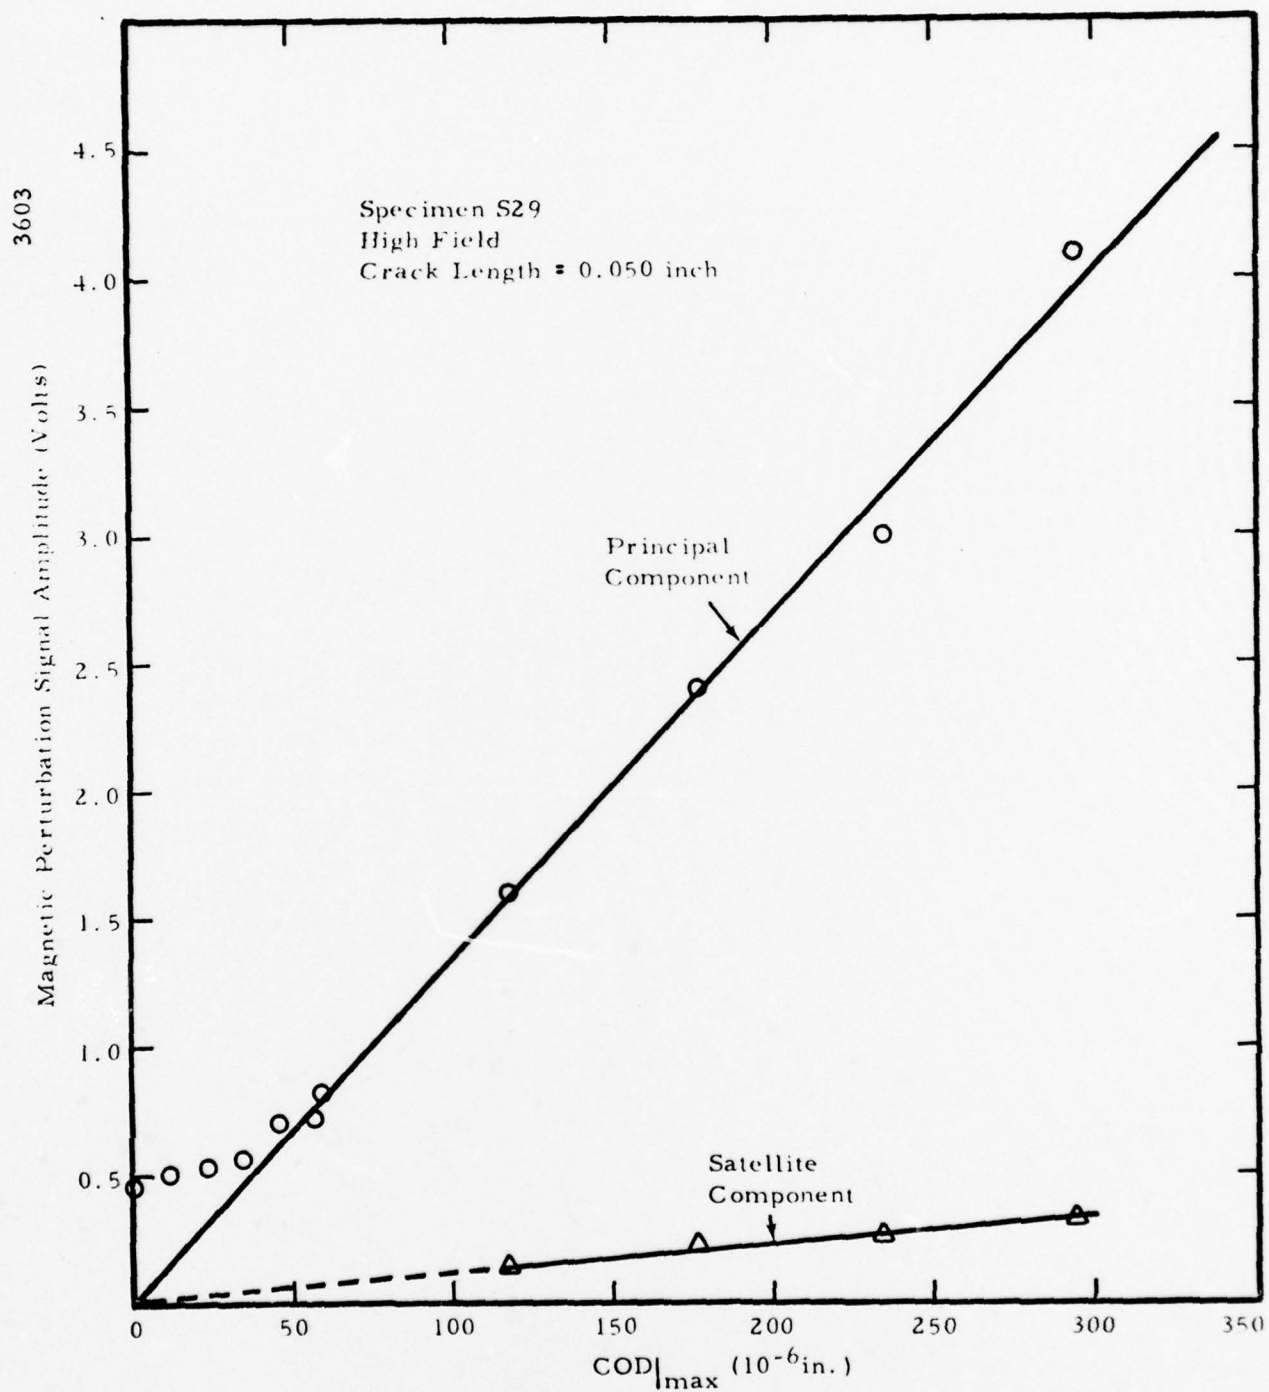
FIGURE 7. MAGNETIC PERTURBATION SIGNAL AMPLITUDE VERSUS $COD|_{max}$

As discussed in the previous section, the magnetic perturbation signal amplitude changes slowly at first as the load is increased and then varies linearly with COD_{max} beyond a certain load level (see Figures 6 and 7). These results are consistent with an interpretation in terms of crack closure. However, the general pattern of magnetic perturbation signal amplitude change with load at different positions along the crack interface in a specimen cycled at a high stress level is not consistent with the usual conception of a closure model, at least for center and edge notched specimens, whereby the crack is closed by a pattern of residual stresses and strains at the crack tip. Since the center of the crack is farthest from the crack tips, it would be expected to open first under load before other positions on the crack interface open. It would not, therefore, be expected that all positions on the crack interface would be open at the same value of applied load unless the closure effect was very small. In Figure 8 are plotted the magnetic perturbation signal amplitude versus applied stress for a 0.030-in. -long crack in Specimen S5, cycled at a stress level near yield, for a number of probe scans along the crack interface. In these plots the scan track locations is designated in terms of circumferential degrees around the specimen. A one-degree increment corresponds to 2.2×10^{-3} inch. The particular tracks associated with the crack center and crack tips are indicated on the figure. As can be seen, in most cases, the magnetic perturbation signal amplitude behaves similarly with stress for all scan tracks along the crack interface, thus implying a small closure effect according to the model discussed above. This is in agreement with results of acoustic investigations which show the closure effect to be small for part-through cracks 0.103-in. -long in AISI 4340 steel.⁽⁷⁾ In addition, if the entire crack interface were closed under no-load then the magnetic perturbation signal amplitudes for the various scan tracks would be expected to all have approximately the same value at zero load. Experimentally, the magnetic perturbation signal amplitude at no-load varies considerably along the crack interface implying that some crack void may still exist at zero load possibly beneath a surface closure. Such a result has been reported by others for through cracks.⁽⁸⁾

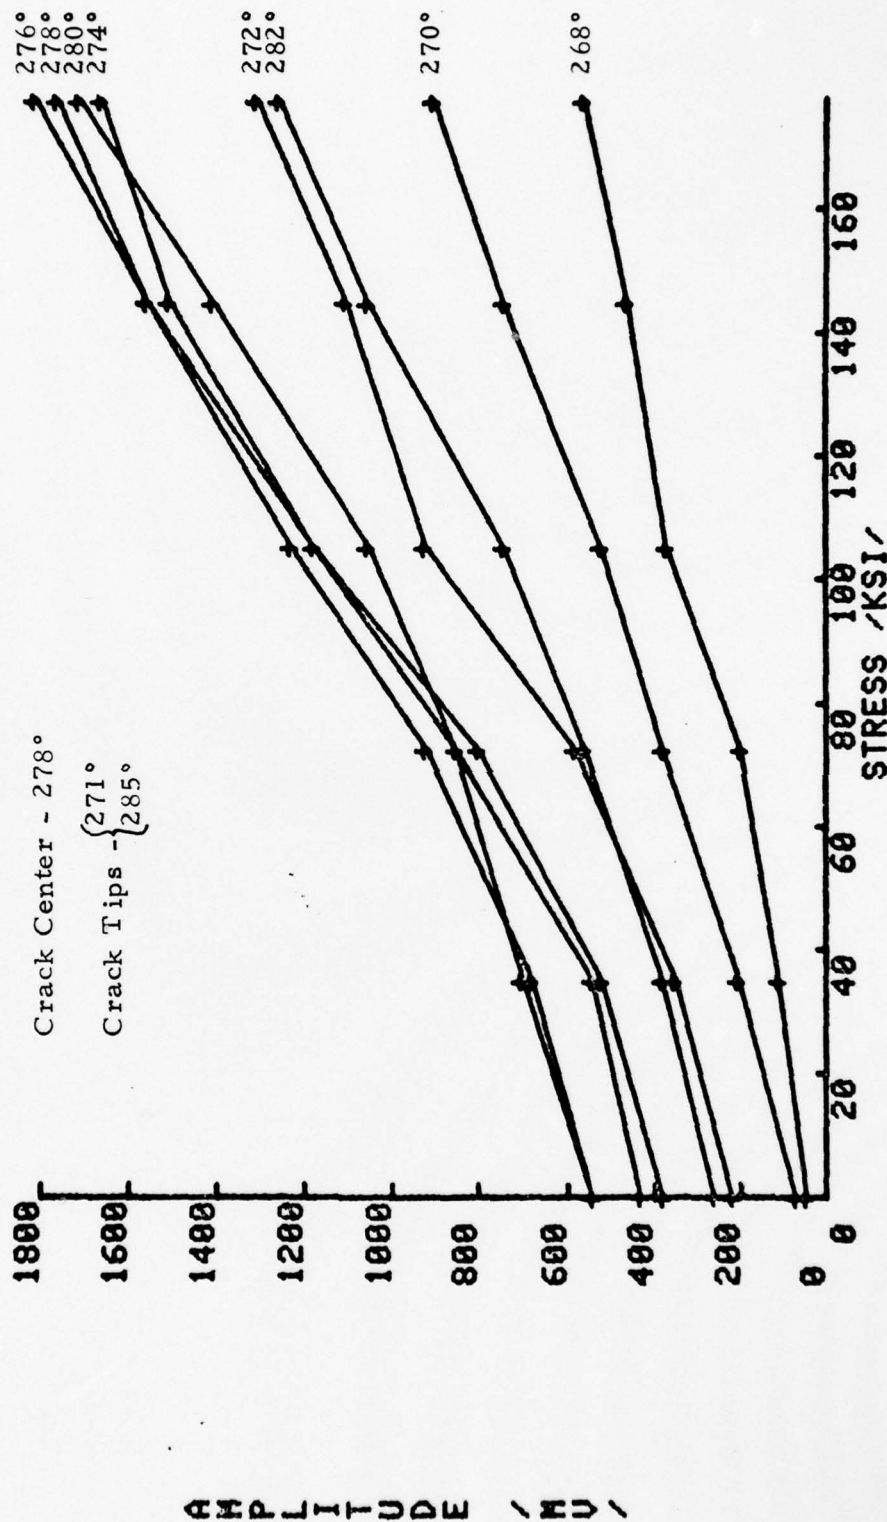
SPECIMEN: S-5
CRACK LENGTH: 0.03 IN.
6/24/77

NO. CYCLES: 8800
MATERIAL: 4340 STEEL
FIELD: HF
CRACK B

Peak Stress: 180 ksi

FIGURE 8. PRINCIPAL SIGNAL PEAK AMPLITUDE VERSUS STRESS FOR VARIOUS SCAN TRACKS ALONG THE CRACK INTERFACE

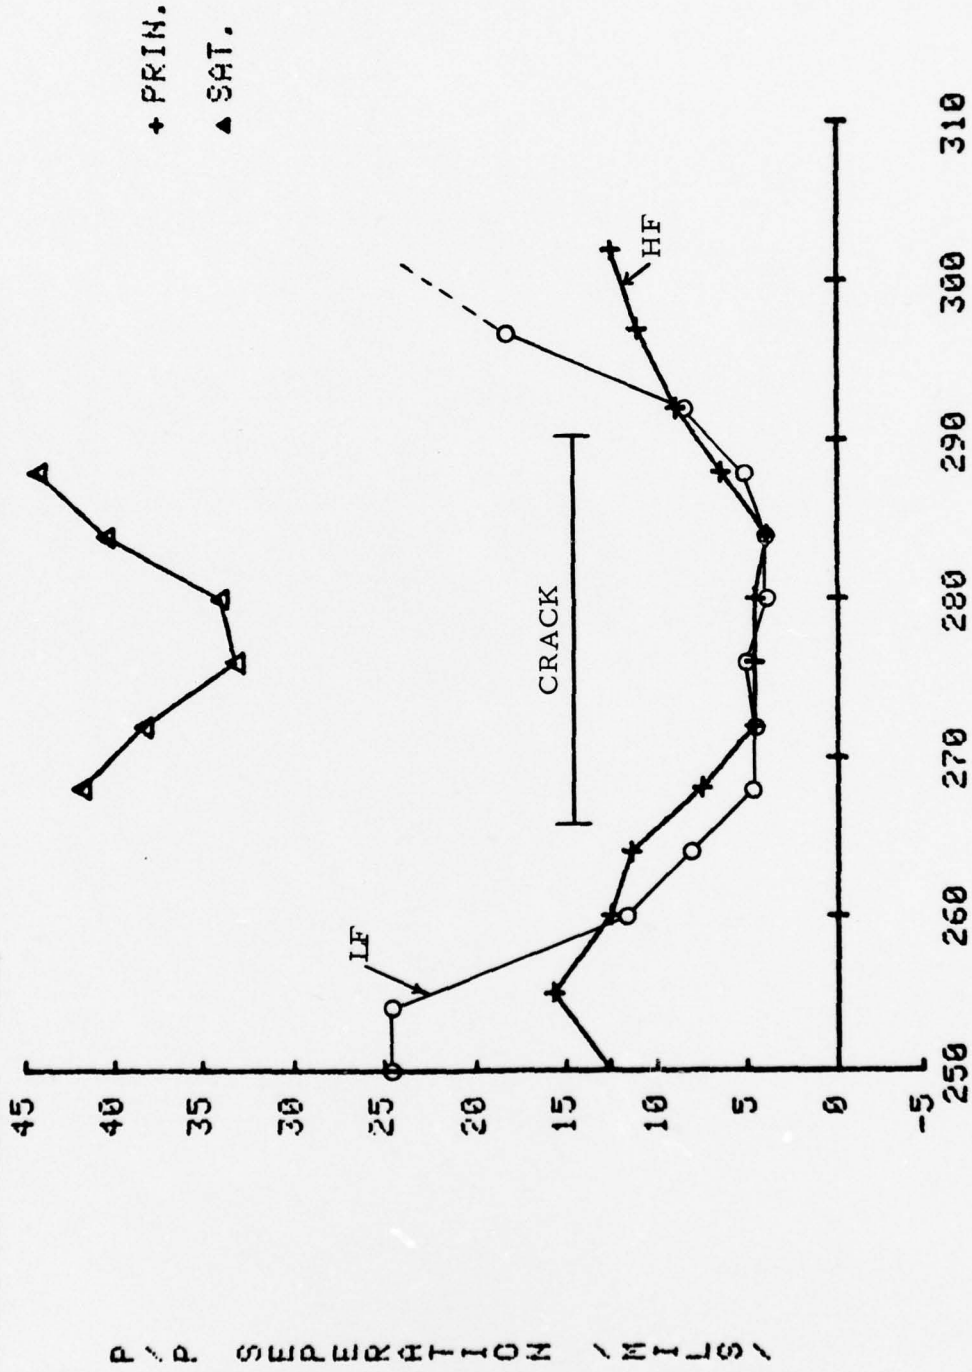
7/9/76 SPECIMEN: S-5
 CRACK LENGTH: 0.052"
 LOAD: FL FL=180KSI FIELD: HF

MATERIAL: 4340 STEEL
 NO. CYCLES: 9900
 COMMENTS: CRACK "B"

FIGURE 9. MAGNETIC PERTURBATION SIGNAL PEAK SEPARATION VERSUS LOCATION ALONG A CRACK INTERFACE.

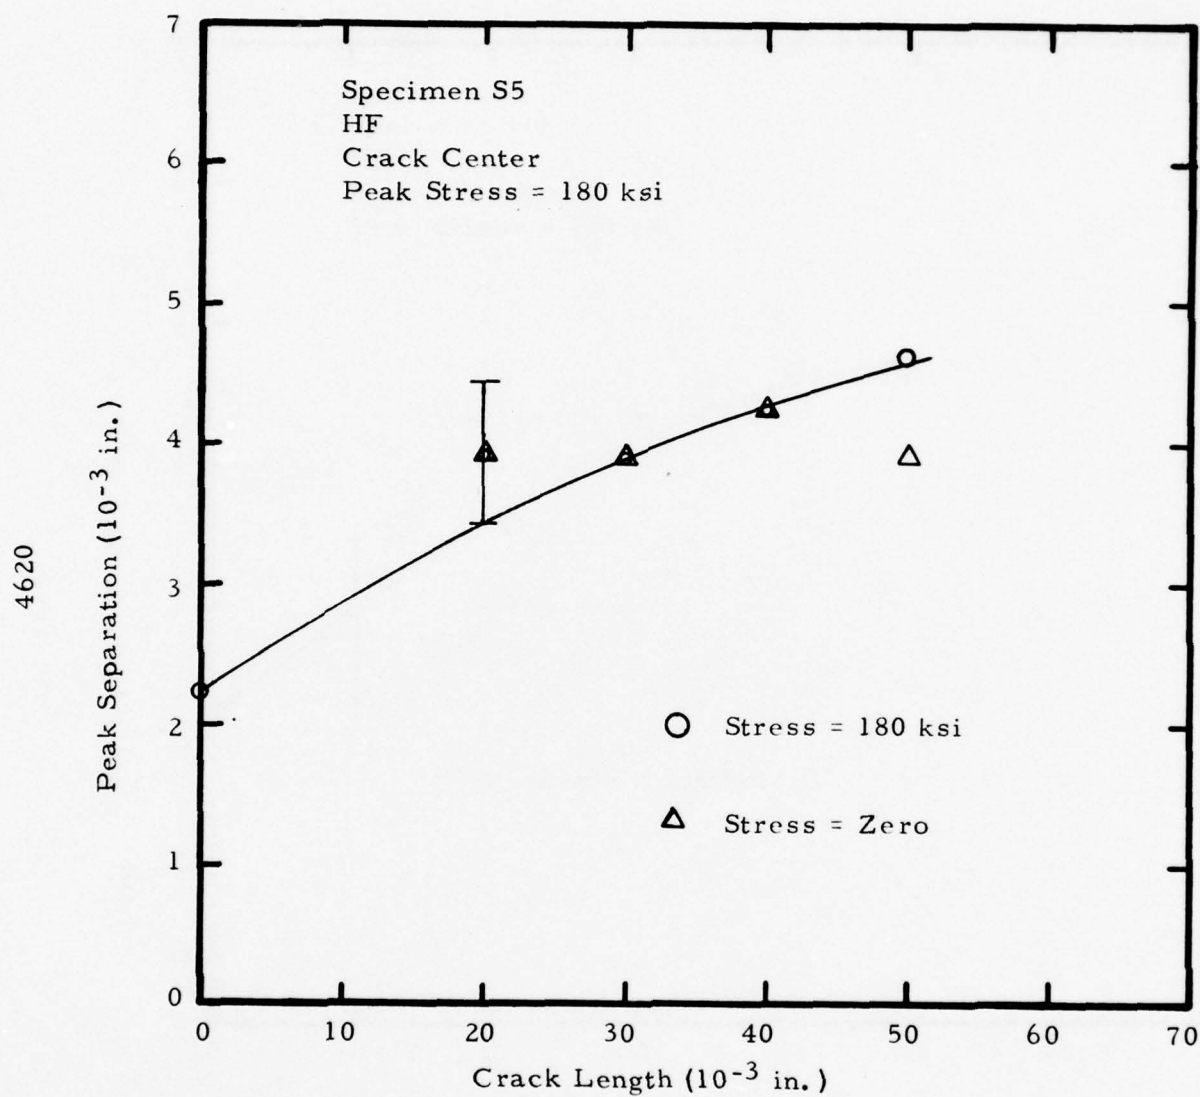
FIGURE 10. PEAK SEPARATION OF MAGNETIC PERTURBATION PRINCIPAL COMPONENT AT CRACK CENTER VERSUS CRACK LENGTH. Specimen S5

As is noted in the results presented in Figures 10 and 12, within limits of the experimental measurements, the magnetic perturbation signal peak separation does not change as the applied stress is changed from zero to its maximum value. This result is shown more clearly in the data presented in Figure 14 for Specimen S29. As is seen, the signal peak separation is essentially independent of applied load despite the fact that the magnetic perturbation signal amplitude increases by a factor greater than 9 over the same range (see Figure 6).

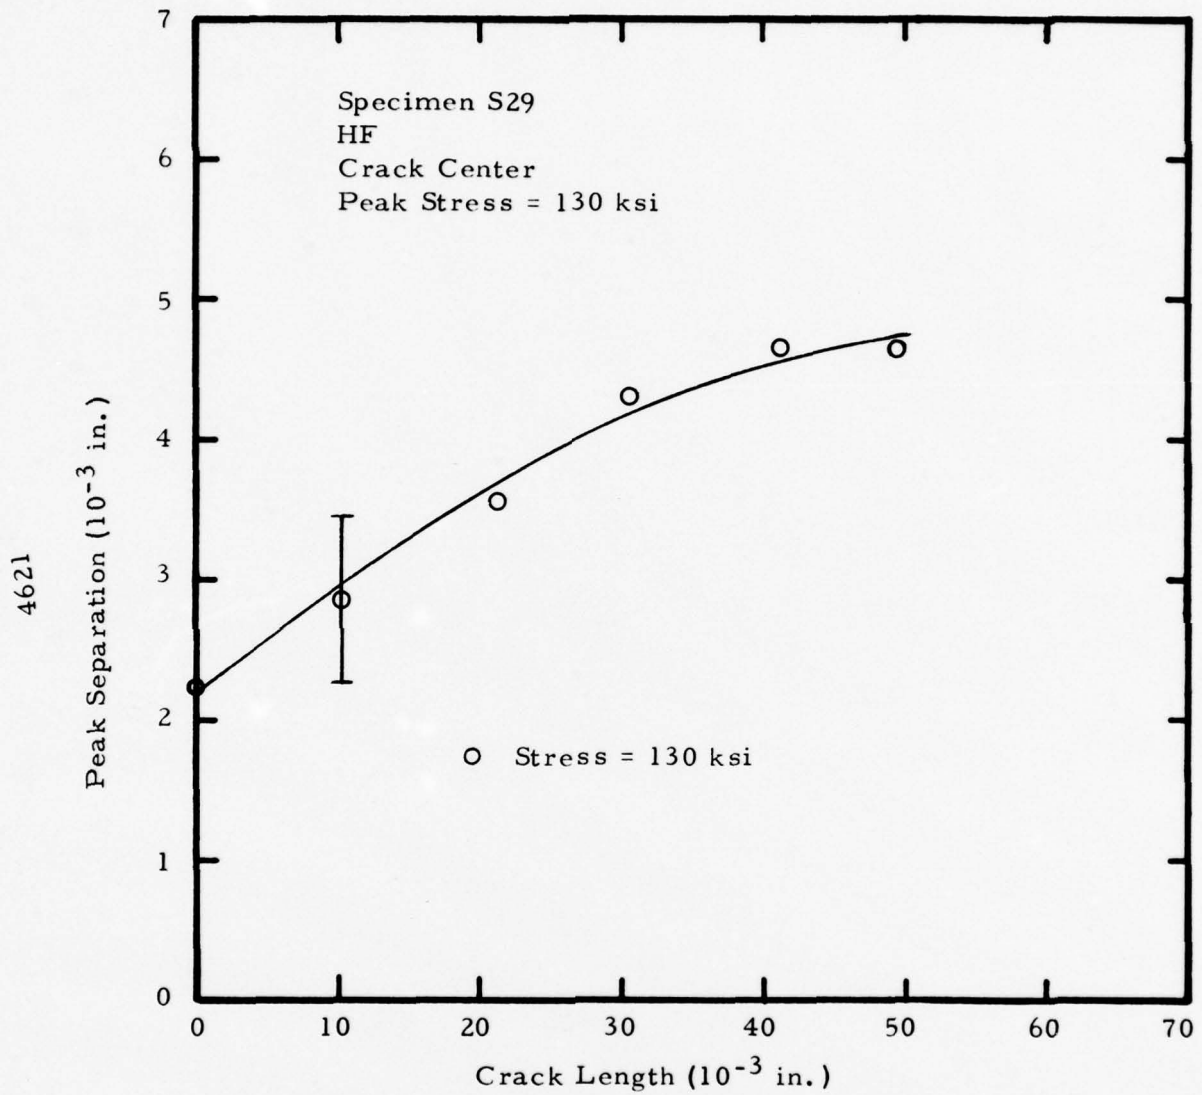
FIGURE 11. PEAK SEPARATION OF MAGNETIC PERTURBATION PRINCIPAL COMPONENT AT CRACK CENTER VERSUS CRACK LENGTH. Specimen S29

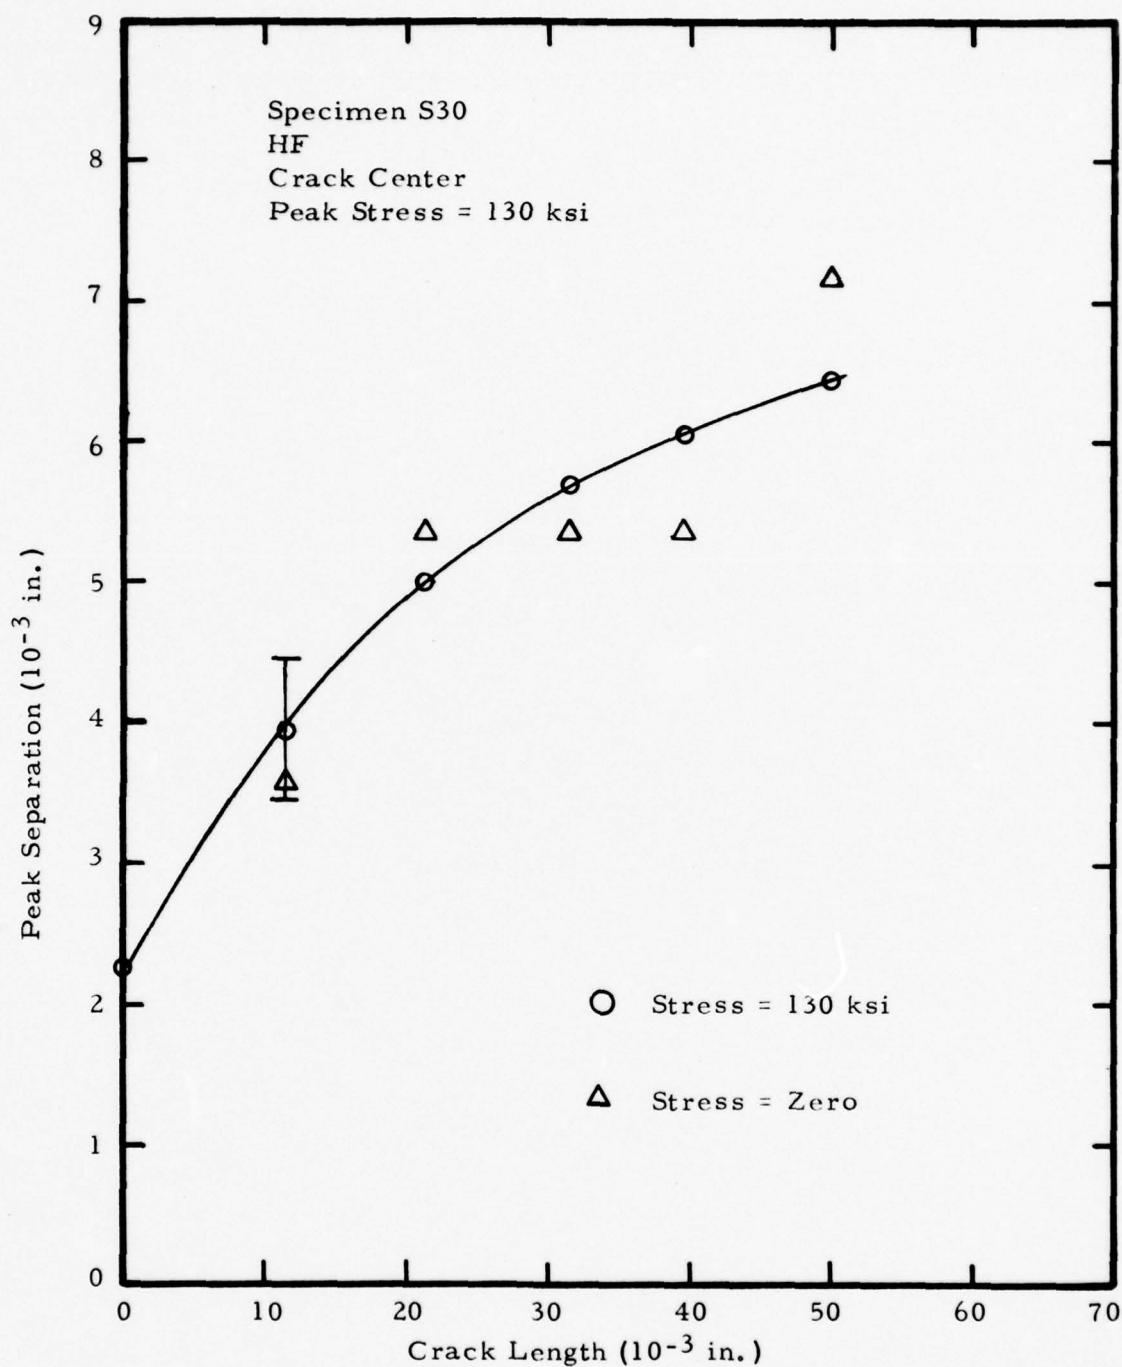
FIGURE 12. PEAK SEPARATION OF MAGNETIC PERTURBATION PRINCIPAL COMPONENT AT CRACK CENTER VERSUS CRACK LENGTH. Specimen S30

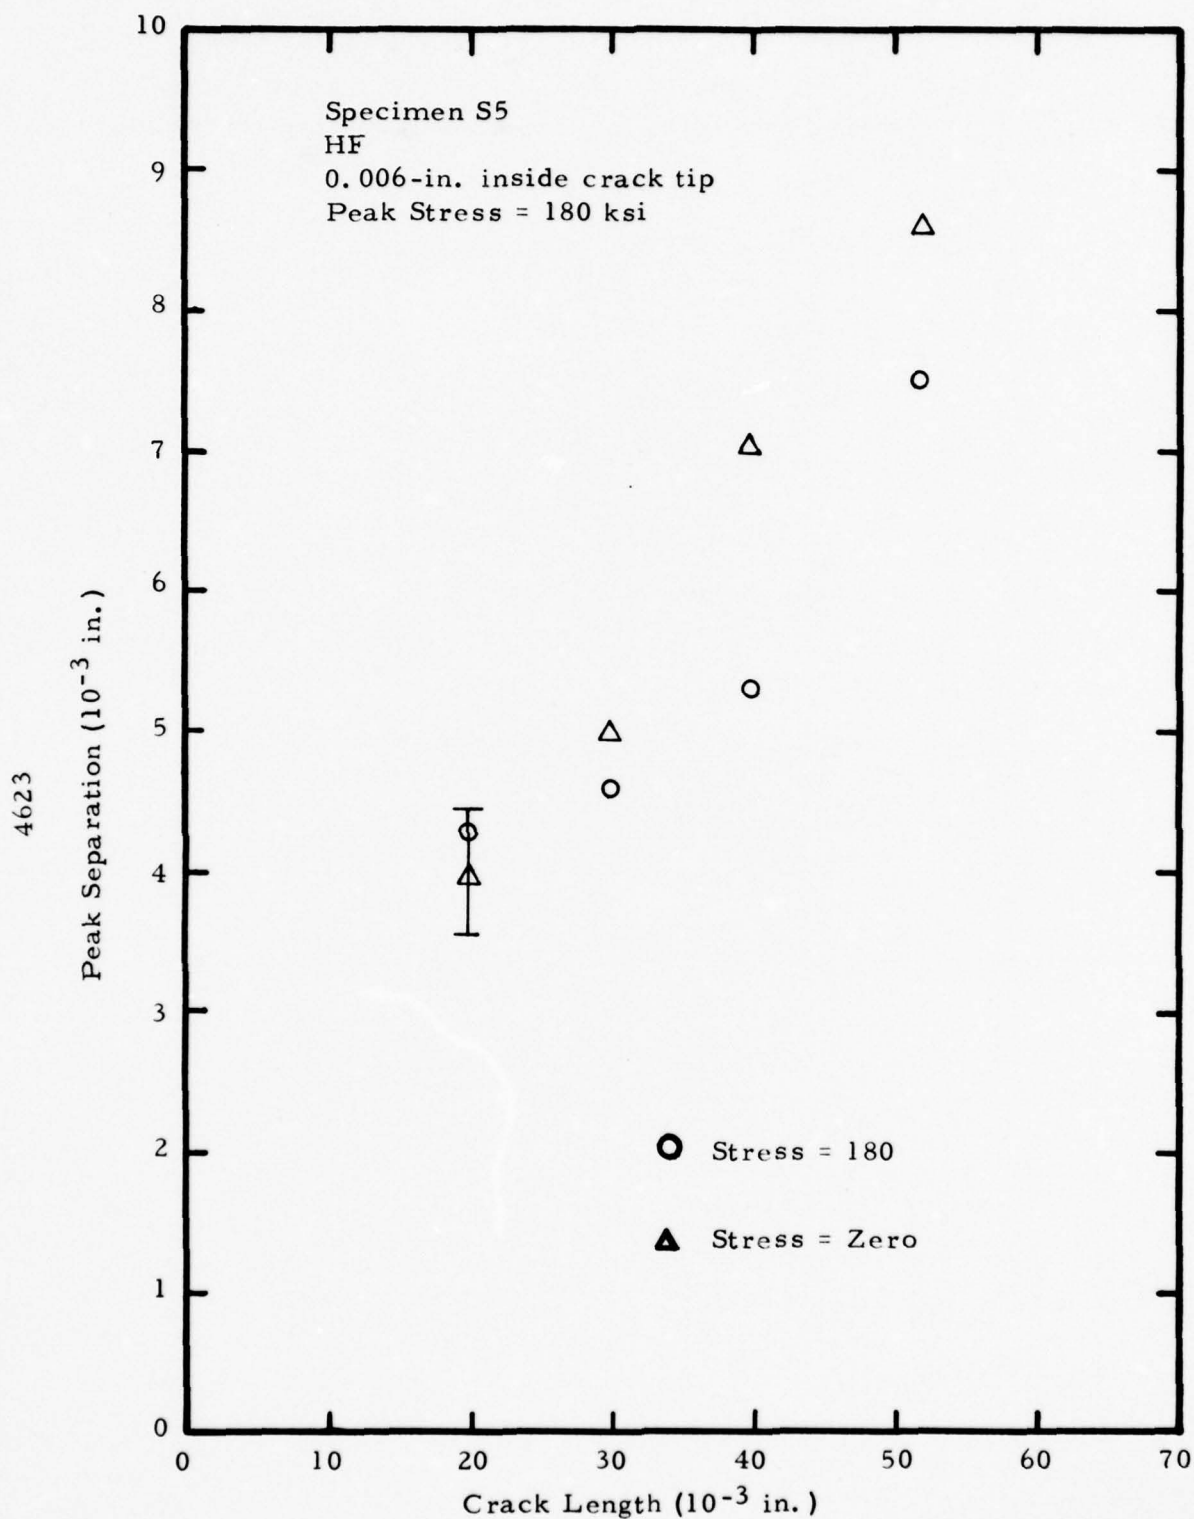
FIGURE 13. PEAK SEPARATION OF MAGNETIC PERTURBATION PRINCIPAL COMPONENT 0.006-IN. INSIDE CRACK TIP VERSUS CRACK LENGTH. Specimen S5

In further exploring the behavior of the magnetic perturbation signal peak separation, Figure 13 shows this parameter obtained along scan tracks approximately 6×10^{-3} -in. inside the crack tips plotted against crack length for Specimen S5 which was cycled at a stress level near yield. Note that for these scan tracks near the crack tips, the signal peak separation changes more with crack length than for scan tracks over the crack center (compare Figure 10), even though the change in crack depth with length is greater at the center than at the tip. Because of the high stress level at which the specimen investigated was cycled, the results observed for the magnetic perturbation signal peak separation at the crack tips may be associated with the severely worked plastic zones around the fatigue crack. This, however, has not yet been shown conclusively.

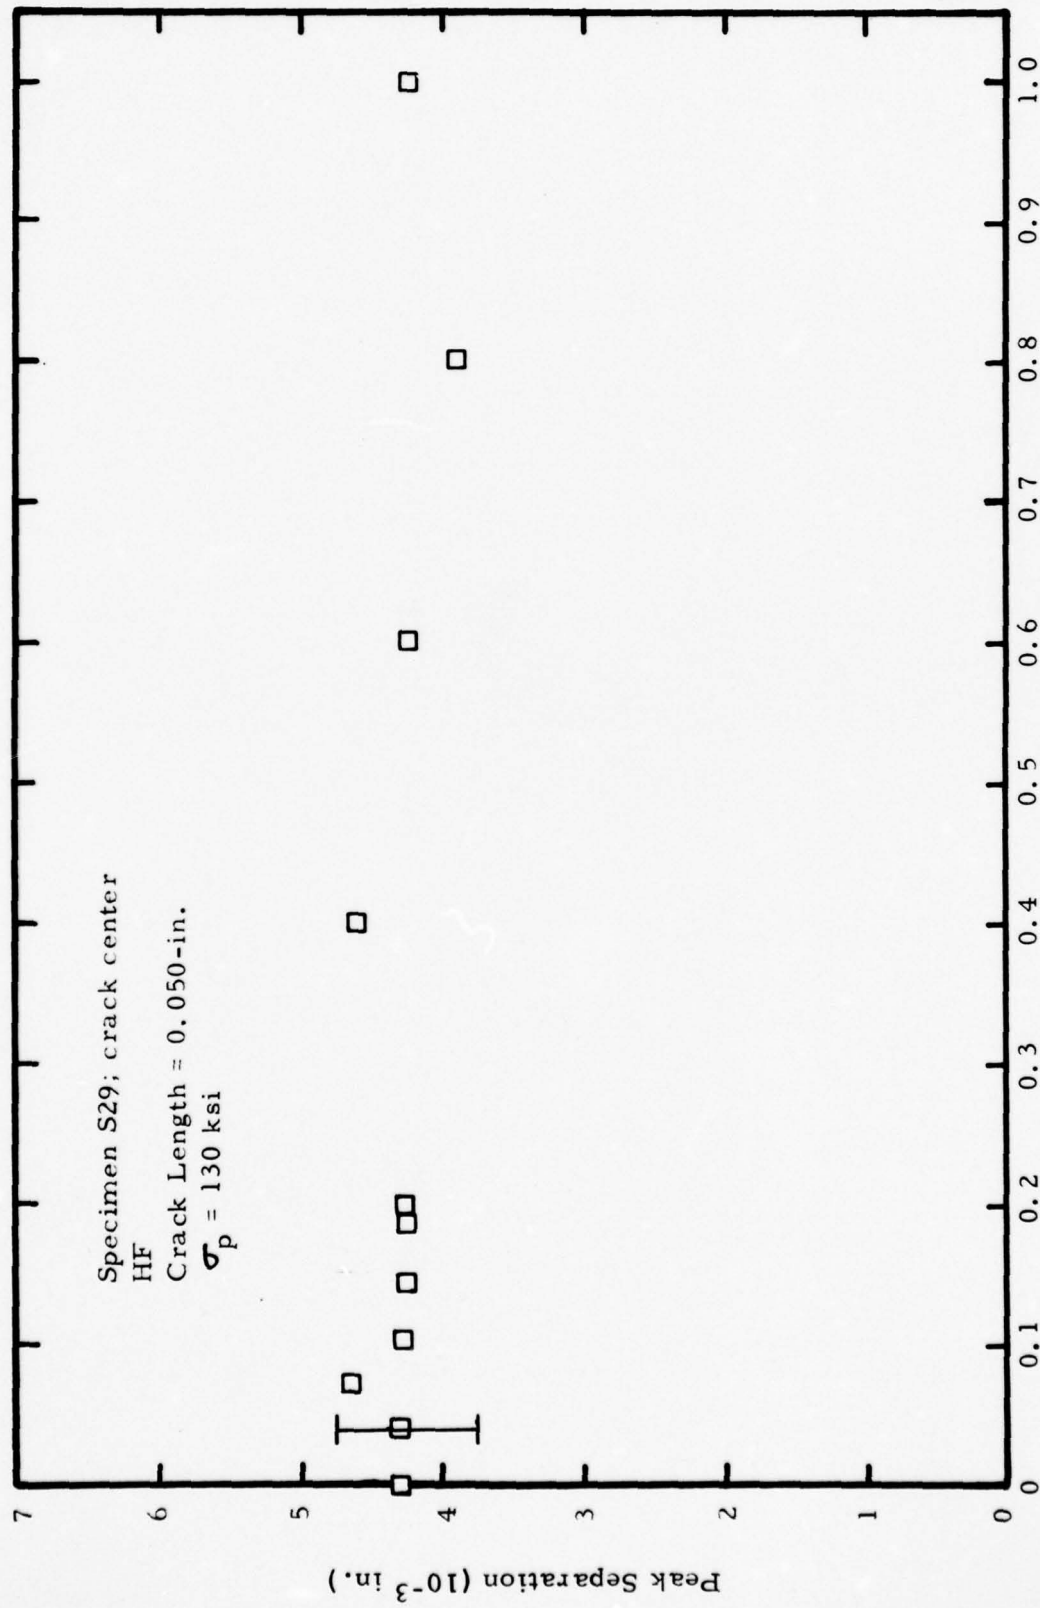
FIGURE 14. MAGNETIC PERTURBATION PRINCIPAL COMPONENT PEAK SEPARATION VERSUS APPLIED STRESS

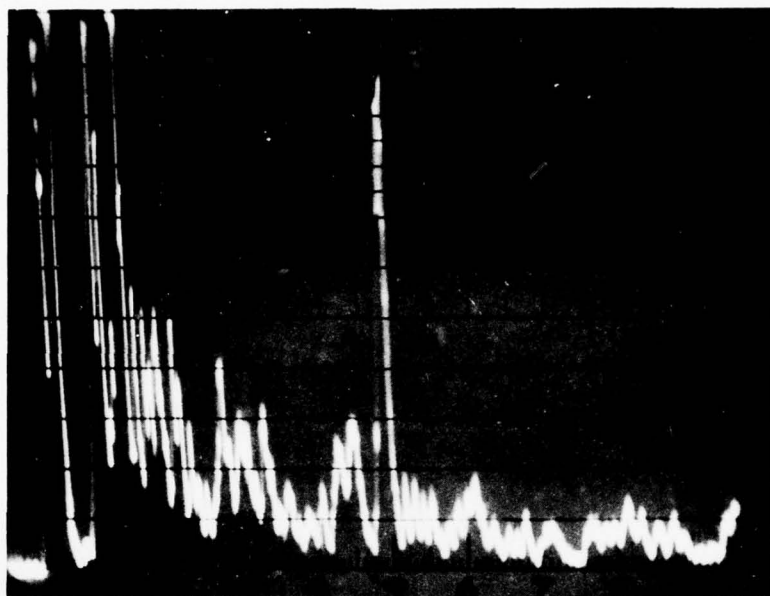
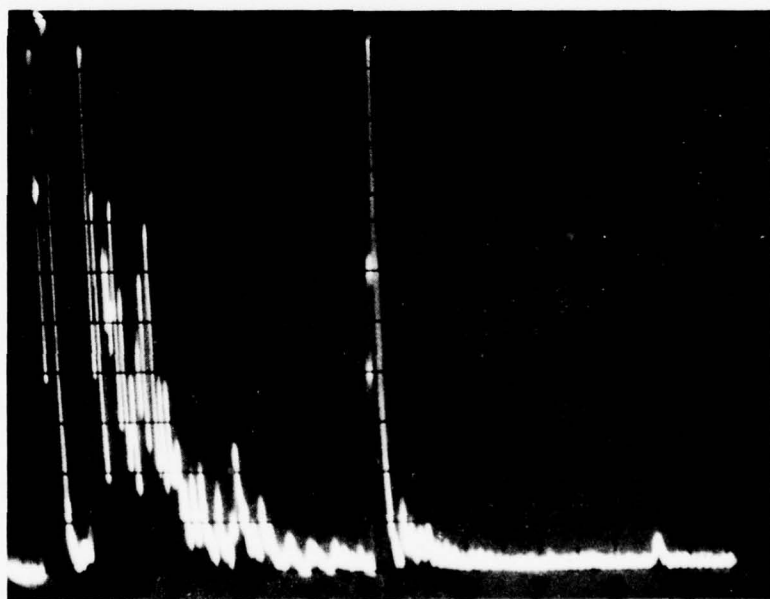
a. HY-180

b. AISI 4340

FIGURE 15. ULTRASONIC PULSE-ECHOES FROM A DRILLED HOLE

Although only limited ultrasonic data were acquired, a comparison of the responses obtained from AISI 4340 with HY 180 shows significant differences. Figure 15 shows a comparison between ultrasonic pulse-echo reflections obtained from drilled holes 0.02-in. -diameter by 0.02-in. -deep in the two materials. Note that the signature from the hole in HY 180 is slightly lower in amplitude than for the identical size hole in AISI 4340; also, the background (material) noise in HY 180 is approximately a factor of 2 to 3 times higher in amplitude than the background noise in

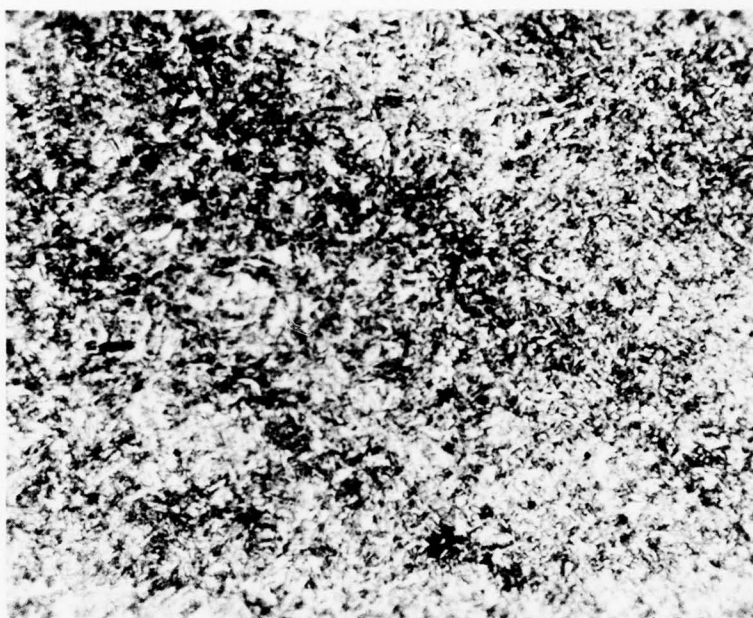
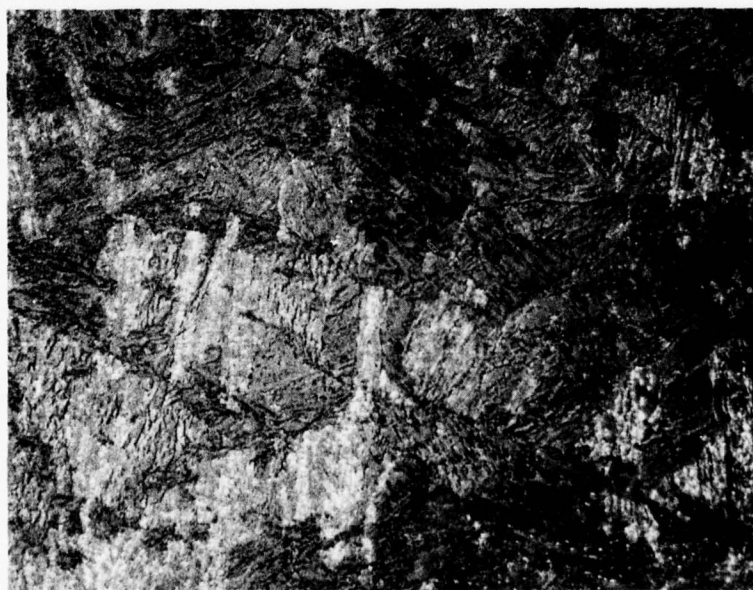
(a) AISI 4340 Steel - Martensitic. Magnification 500X

(b) HY 180 Steel - Bainitic. Magnification 500X

FIGURE 18. METALLURGICAL MICROSTRUCTURES FOR AISI 4340 AND HY 180 STEEL

and etched in nital. The resulting microstructures are shown in Figure 18. As would be expected on the basis of the prescribed heat treatments (see Appendix C) the AISI 4340 microstructure consists of tempered martensite while the HY 180 steel is bainitic. In the latter case, the bainite colonies appear to delineate the prior austenite boundaries.

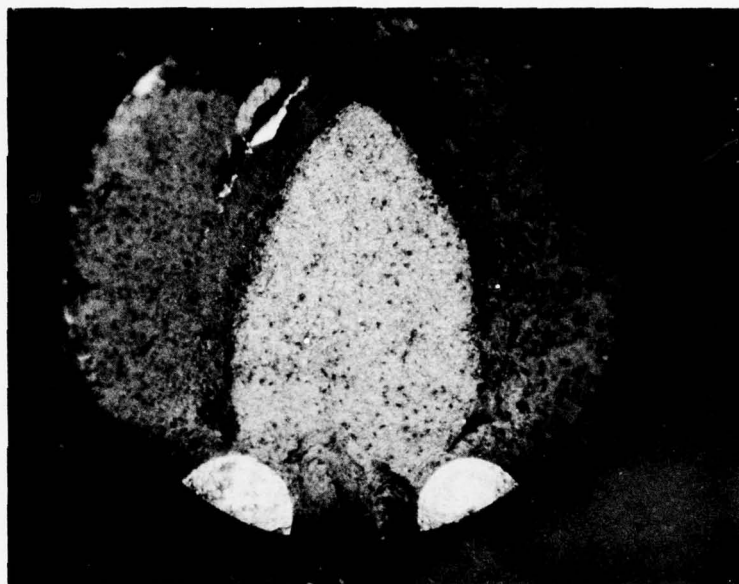
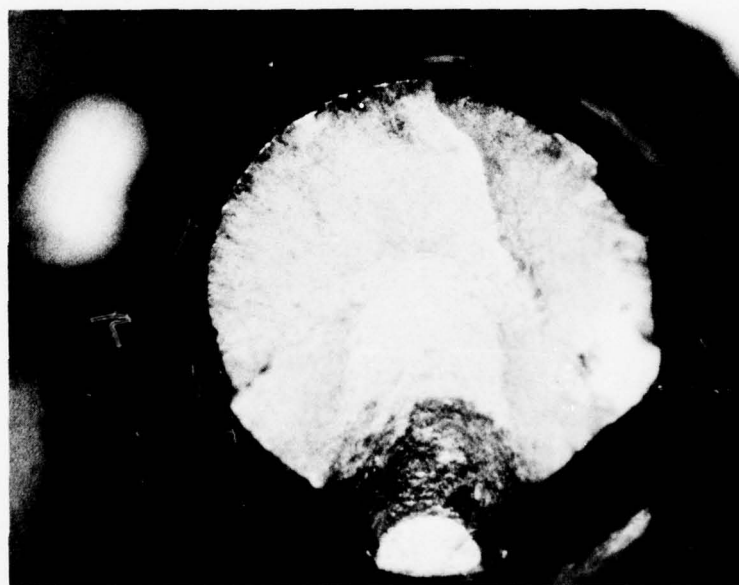
(a) AISI 4340 Steel Specimen S5. Arrows Indicate Fatigue Cracks. Magnification 12.8X

(b) HY 180 Steel Specimen H1. Magnification 12.8X

FIGURE 19. FRACTURE SURFACES FOR AISI 4340 AND HY 180 STEEL

In this section, a brief comparison of fatigue crack initiation in the two materials AISI 4340 and HY 180 steel is presented. Figure 19 shows the macroscopic fractography of an AISI 4340 specimen (S5) and a HY 180 specimen, each cycled at a peak stress of 180 ksi. The specimens were cooled to -78°C by packing in dry ice and fractured using a standard tensile machine. In the case of the AISI 4340 specimen (Figure 19a), two fatigue cracks (arrows) coalesced during the final stages of fracture. It is apparent that the two grew stably, independent of one another, as half-penny shaped cracks. The nuclei of the cracks are shown in Figure 20 (arrows) and can be seen to be large (0.001-in. -diameter) spherical
